**Flood Control Project Maintenance
Levee Inspections**
LMA District Cover Sheet
Spring 2008 Levee Inspection Results

Reclamation District No. 0563

**Flood Control Project Maintenance
Levee Inspections
Unit Cover Sheet
Spring 2008 Levee Inspection Results
Reclamation District No. 0563**

Levee Inspection Report By Mile - Spring 2008

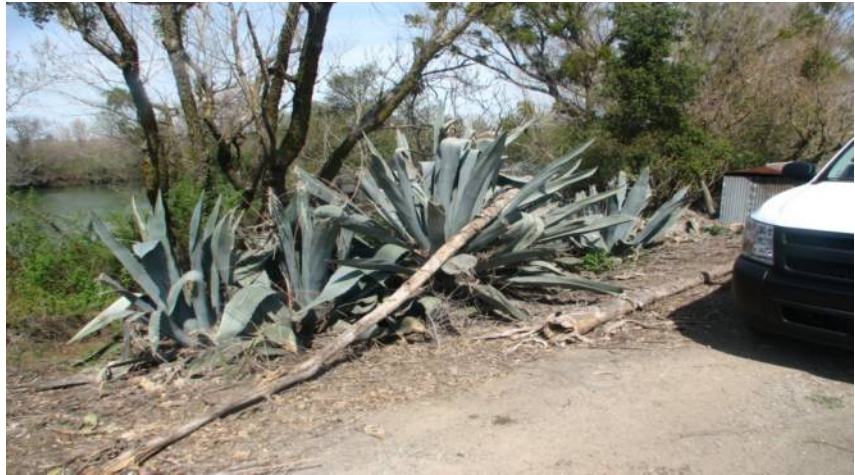
6	1.42	1.42	Earthen Levee	Vegetation	WS	M	Remove the wild growth other than native grasses from the levee slopes. Inspector Comments: Remove century plant from waterward shoulder.	38.224280 ° -121.534377 °	38.224280 ° -121.534377 °	Y	6
7	1.91	2.20	Earthen Levee	Encroachments	WS	M	Prunings	38.222720 ° -121.542815 °	38.218975 ° -121.542667 °		7
8	2.03	2.21	Earthen Levee	Encroachments	LS	M	Prunings	38.221358 ° -121.543397 °	38.218795 ° -121.542657 °		8
9	2.32	2.44	Earthen Levee	Encroachments	WS	M	Prunings	38.217395 ° -121.542380 °	38.216242 ° -121.540835 °		9
10	2.33	2.43	Earthen Levee	Encroachments	LS	M	Prunings	38.217212 ° -121.542190 °	38.216317 ° -121.541002 °		10
11	2.44	2.45	Earthen Levee	Vegetation	LS	U	Elderberries are blocking visibility and flood fight capability.	38.216242 ° -121.540835 °	38.216147 ° -121.540612 °		11
12	2.46	2.46	Earthen Levee	Vegetation	WS	M	Elderberries are blocking visibility and flood fight capability.	38.216122 ° -121.540555 °	38.216047 ° -121.540415 °		12

Levee Mile Report Line	6
Start Levee Mile	1.42
End Levee Mile	1.42
Location	
Category	Earthen Levee
Item	Vegetation
Century plant on waterward shoulder at LM 1.42

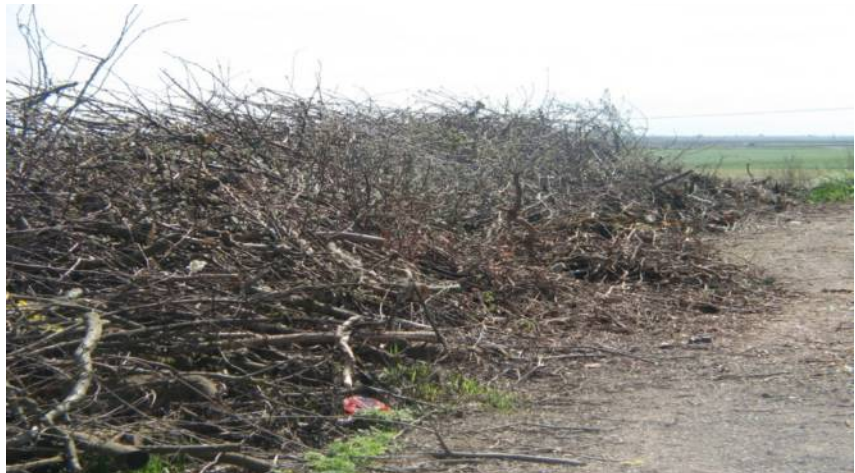
Levee Mile Report Line	16
Start Levee Mile	2.93
End Levee Mile	2.95
Location	
Category	Earthen Levee
Item	Encroachments
Prunings on landward shoulder from LM 2.93 to 2.95

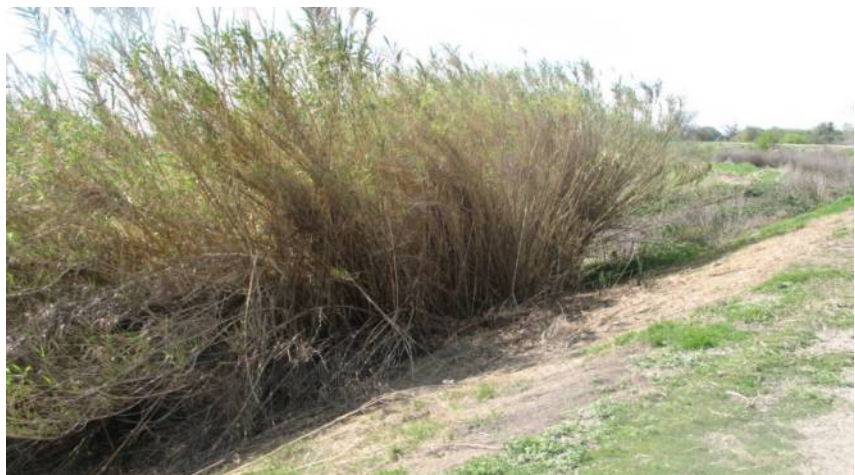
Levee Mile Report Line	17
Start Levee Mile	3.05
End Levee Mile	3.05
Location	
Category	Earthen Levee
Item	Vegetation
Bamboo at landward toe at LM 3.05

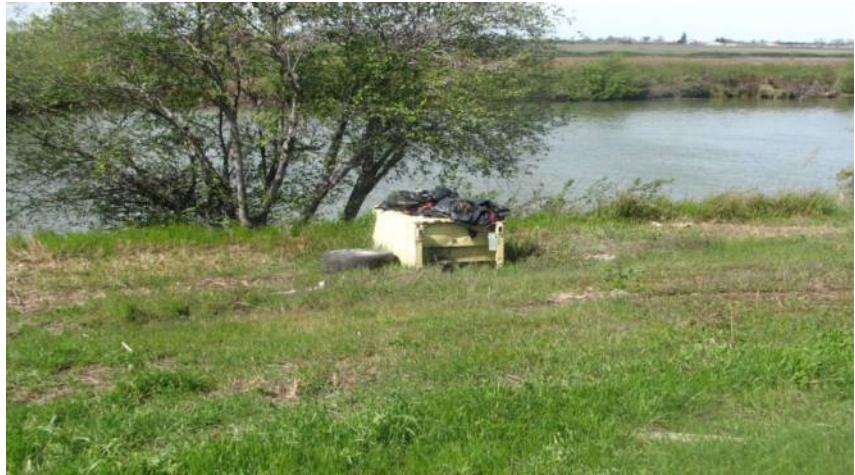
Levee Mile Report Line	20
Start Levee Mile	4.27
End Levee Mile	4.27
Location	
Category	Earthen Levee
Item	Encroachments
Garbage at waterward berm at LM 4.27

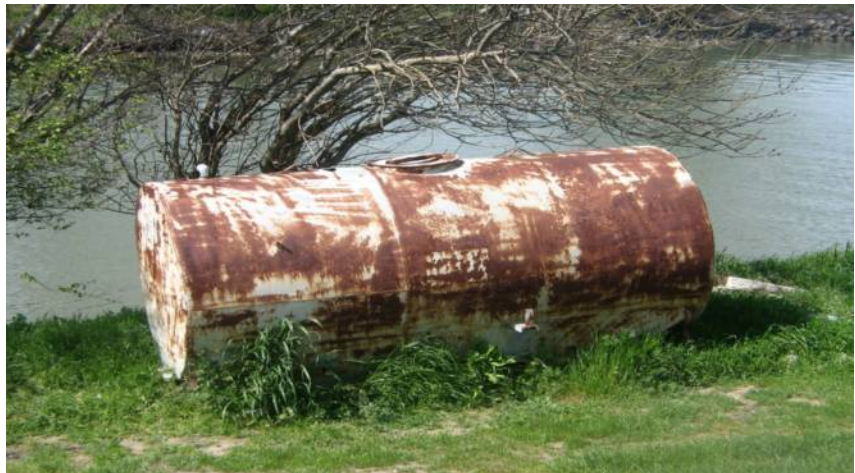
Levee Mile Report Line	21
Start Levee Mile	4.40
End Levee Mile	4.40
Location	
Category	Earthen Levee
Item	Encroachments
Old fuel tank at waterward berm at LM 4.40

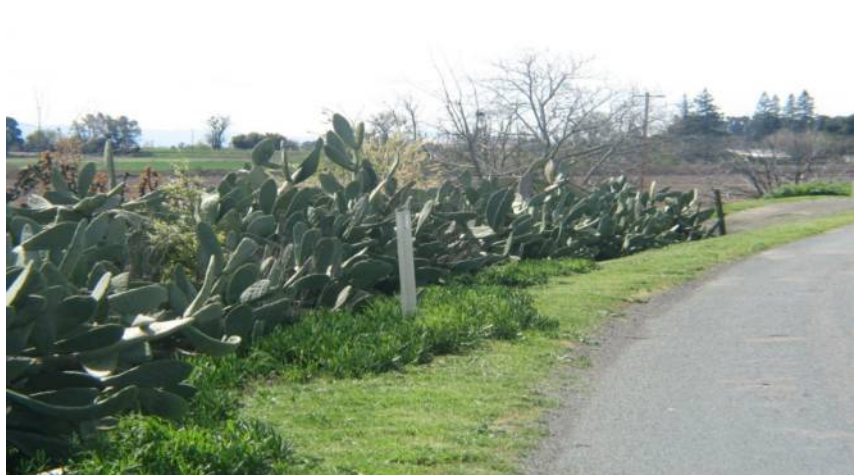
Levee Mile Report Line	22
Start Levee Mile	6.04
End Levee Mile	6.08
Location	
Category	Earthen Levee
Item	Encroachments
Large Cactus plant on landward slope from LM 6.04 to 6.08
